**BOWEN ISLAND
FISH & WILDLIFE CLUB**

**CARTER POND
Sediment Removal Project**

Bowen Island 2014

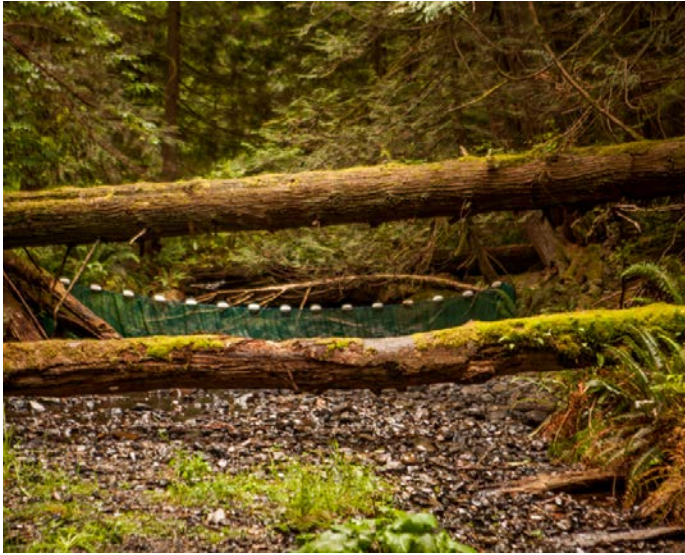
Fish net is secured across Terminal Creek upstream of Carter Pond. Fish, mainly cutthroat trout, are trapped and moved above the fish net.

BIFWC volunteers placed a fish net on Terminal Creek upstream of Carter Pond then trapped fish over several days, rescuing mainly cutthroat trout by trapping and relocating them above the fish net. When as many fish as possible had been trapped, BIFWC volunteers removed the three stop logs on the dam one-at-a-time using ropes with hooks to gradually raise the stop logs so that sudden surges of water didn't wash downstream. On the Friday afternoon before the long weekend the J&E Backhoe excavator created a pool where Terminal Creek enters Carter Pond and the J&E crew ran a 6" PVC sectional plastic pipe from the pool over the dam where the stop logs had been. Therefore, clear water from Terminal Creek was gravity fed over the dam to keep Terminal at full-flow downstream.

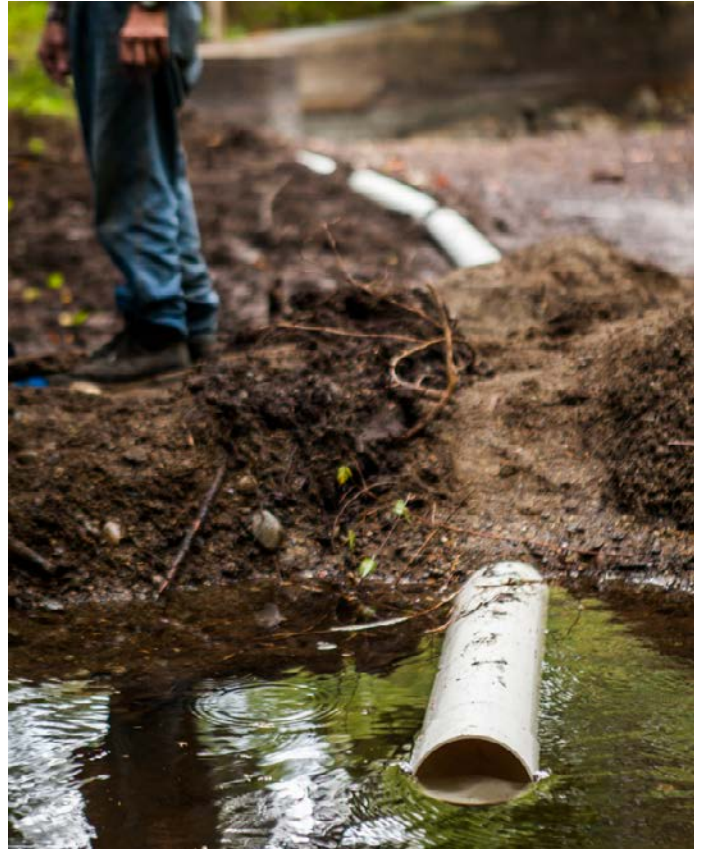
After fish are rescued from Carter Pond, the excavator digs a hole to create a pool where Terminal Creek enters Carter Pond. The 3 stop logs on the dam are removed one-at-a-time using ropes with hooks which attach to the hooks on the stop logs. For safety reasons, BIFWC volunteers are careful not to create sudden heavy surges of water over the dam into Terminal Creek downstream. A 6" PVC sectional pipe gravity feeds clear water from the pool over the dam where the stop logs used to be located. Note that only 1 stop log remains (soon to be removed completely) and it has been lifted slightly to allow the water to drain slowly; the same procedure was followed with the top 2 stop logs.

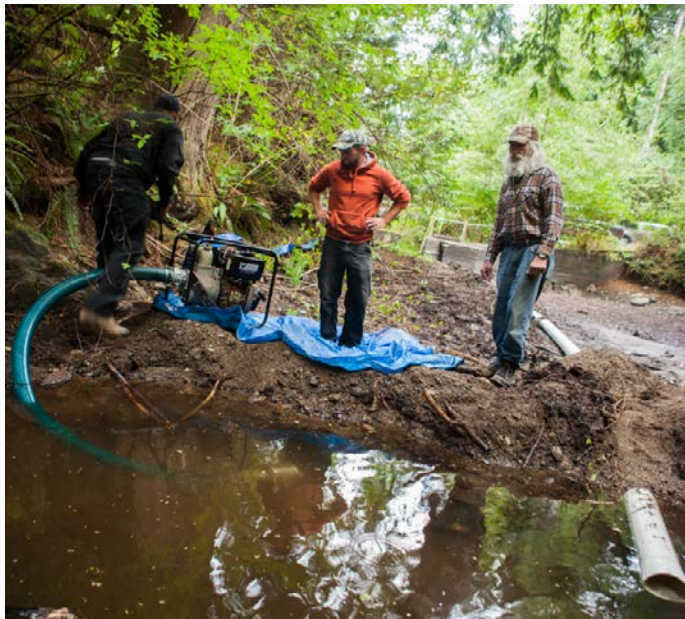
A backup diesel water pump is located beside the pool with the output hose draped over the dam. The water pump will be used to maintain full flow over the dam when the PVC pipe is temporarily removed to allow the excavator to remove sediment from that area.

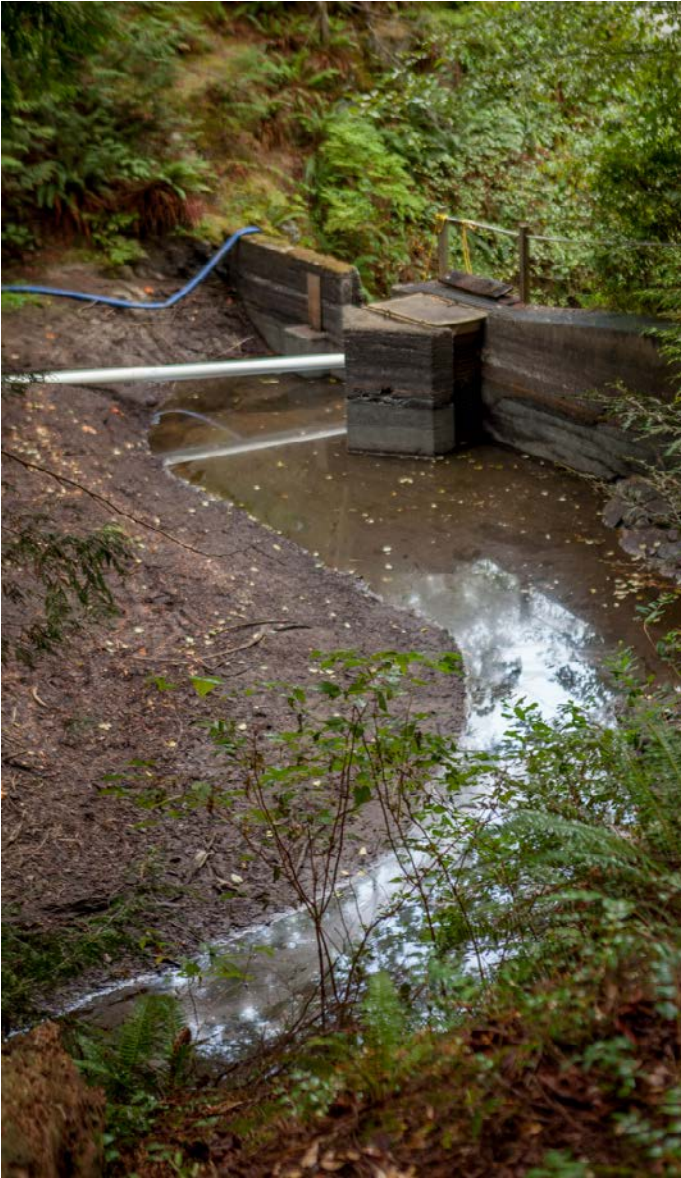
Carter Pond was allowed to drain over the Labour Day long weekend. The sediment lies on top of bedrock.

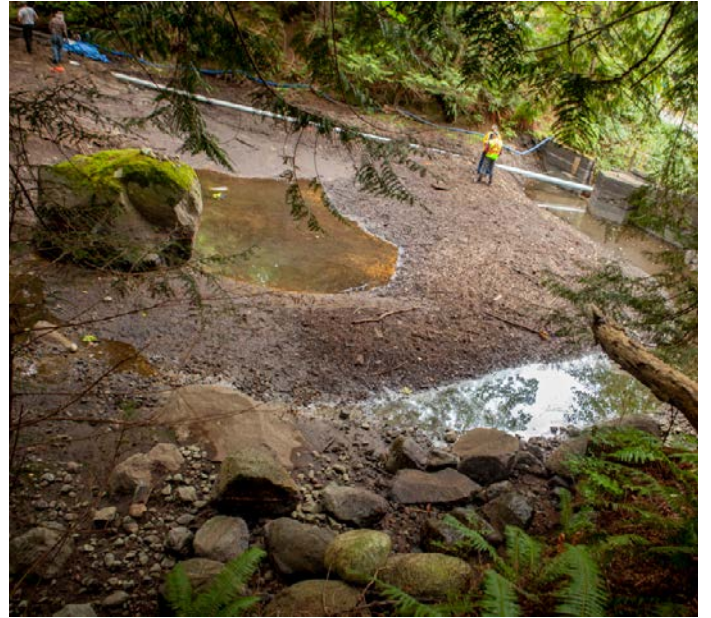
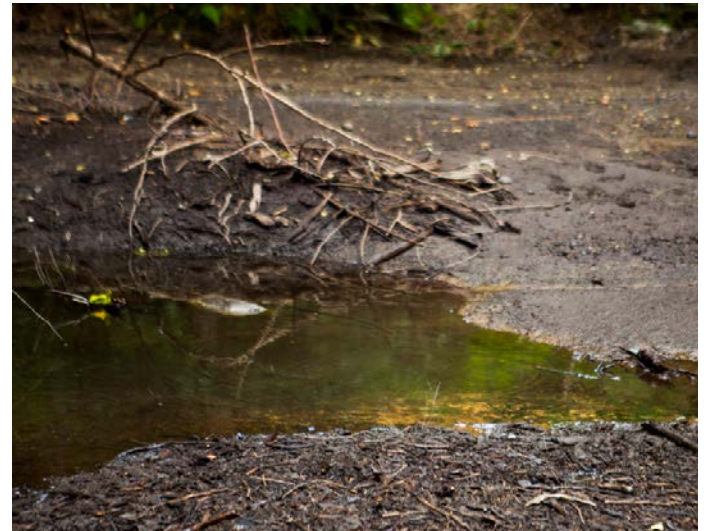
On Tuesday the extent of sediment build-up in Carter Pond is evident. In addition to sediment, trees and logs must be removed.

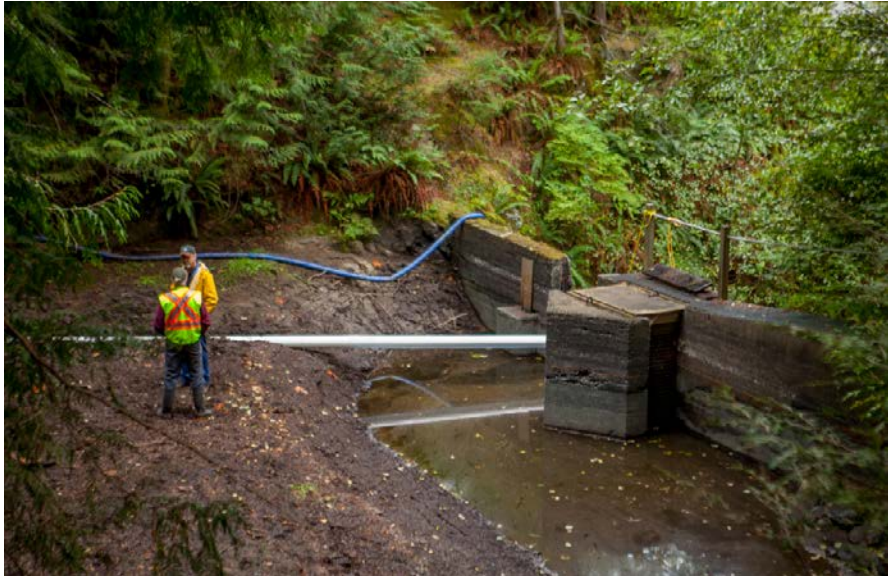
Ed Weismiller and Julian Stevenson of J&E Backhoe remove the PVC pipe temporarily so that sediment can be removed. Note that the pump hose is now directing clear water from Terminal Creek over the dam.

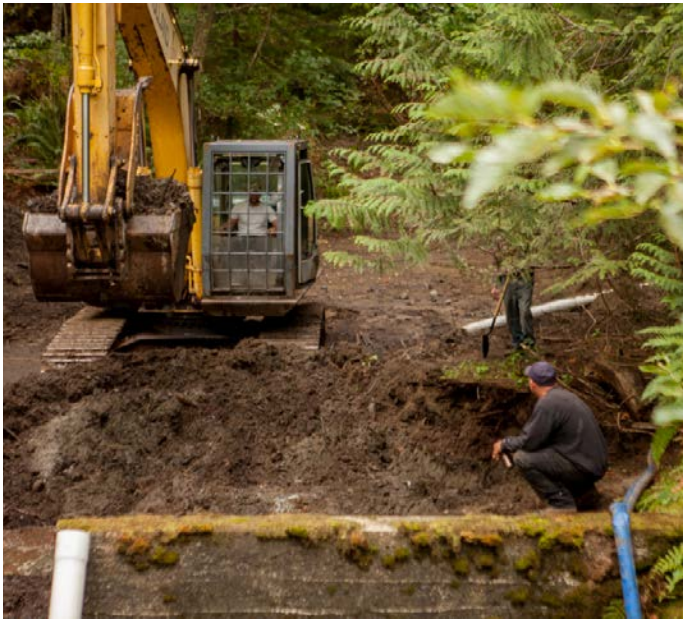
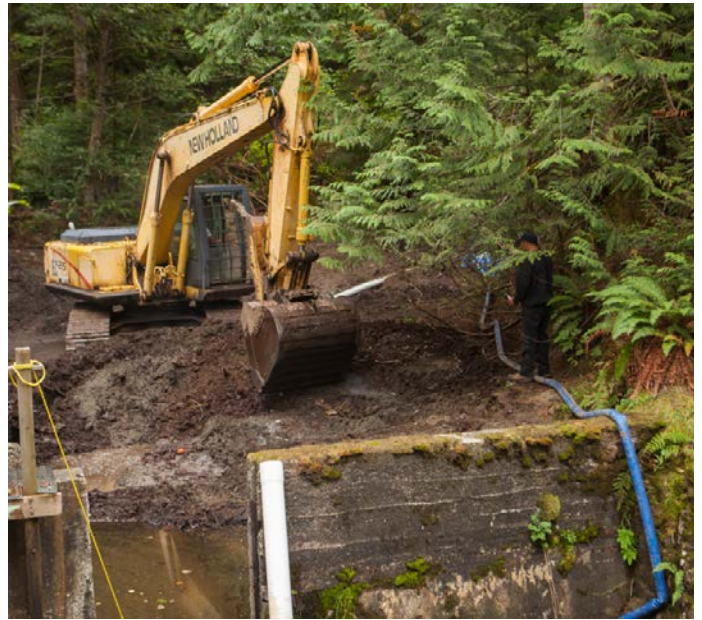
Jamie Weismiller, the J&E excavator operator, can move a lot of material with the 1 yard bucket.

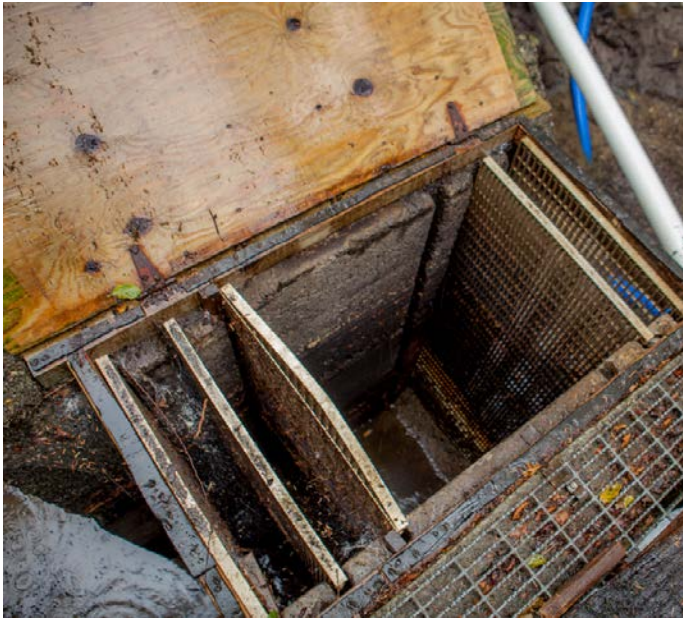
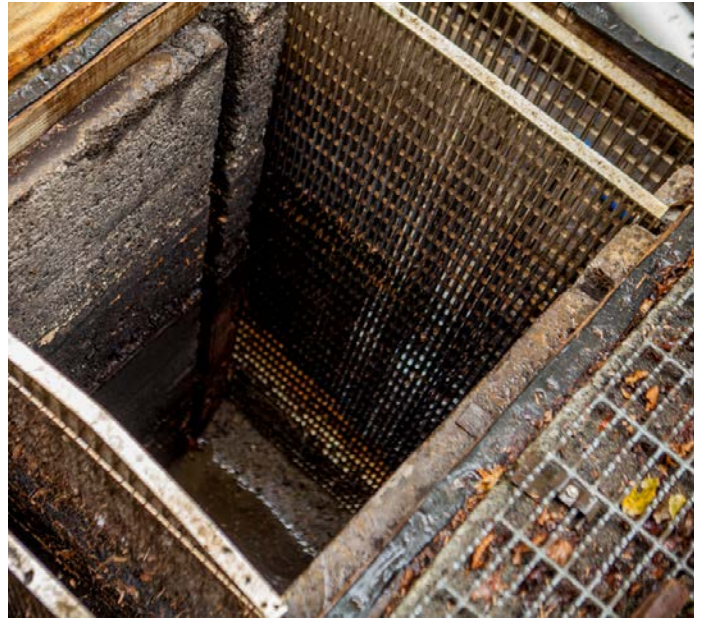
While the excavator removes sediment, BIFWC volunteers remove and clean the 8 heavy hatchery water intake filter grates. Note all the sediment build-up on the grates and that about 3 feet of mud and silt has accumulated at the bottom of the water intake structure right in front of the water intake pipe opening.

After removing and cleaning the grates on the street and shoveling the mud and silt away from the water intake, the grates are replaced. In the future, BIFWC volunteers should clean the grates and remove mud and silt built up in front of the hatchery water intake pipe every year during low water in August or September. This involves carefully removing the stop logs one-by-one to lower the water level in Carter Pond, removing and cleaning the grates, and wearing hip waders to enter the pond and shovel mud and silt from the bottom of the water intake structure.

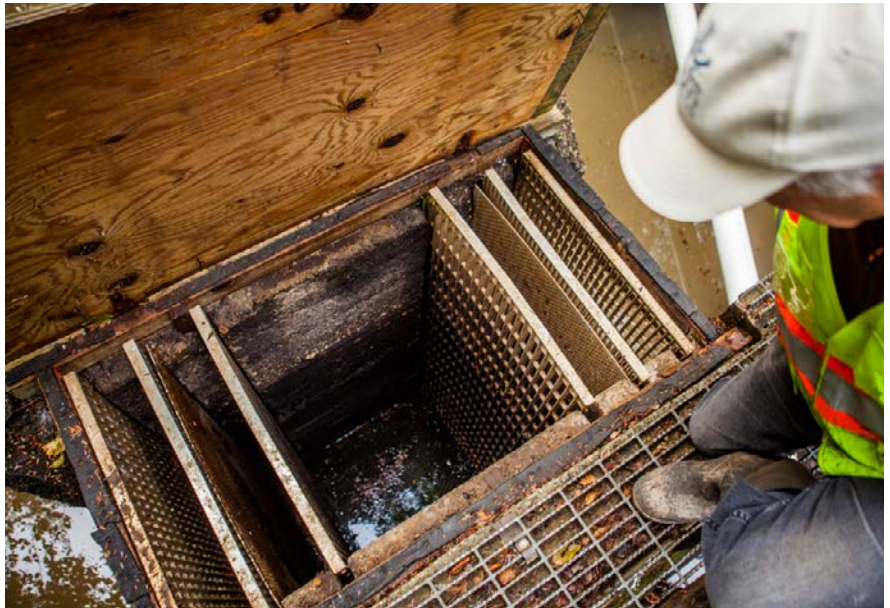
Meanwhile, the excavator has removed all sediment from the side of Carter Pond, the PVC pipe has been re-installed to again allow the gravity feed of water from Terminal Creek over the dam, and the water pump has been turned off.

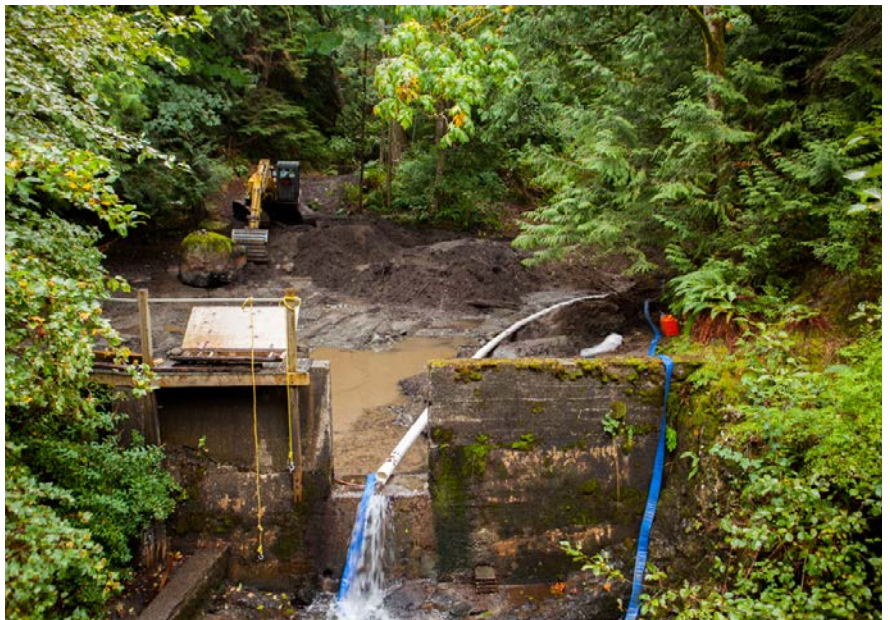
While the rest of the sediment is being removed, clean water continues to flow from Terminal Creek over the dam through the 6" PVC pipe.

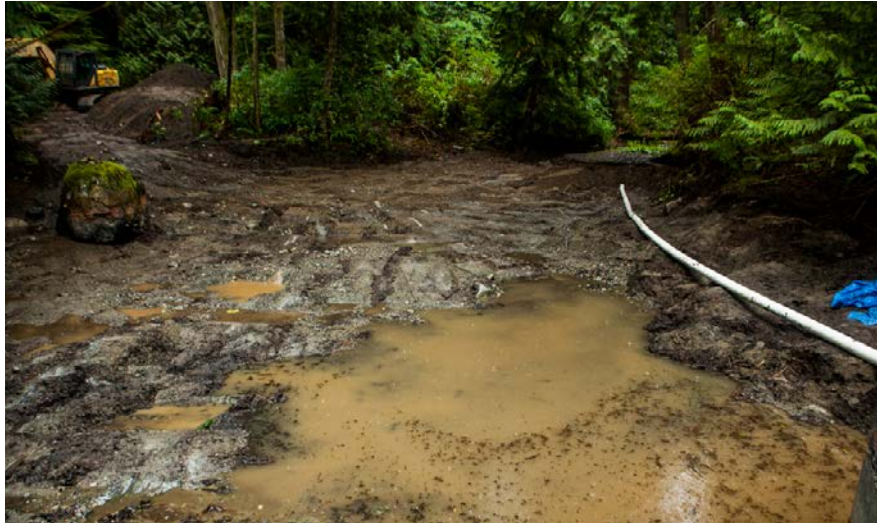
As you can see, the bottom of Carter Pond is bedrock.

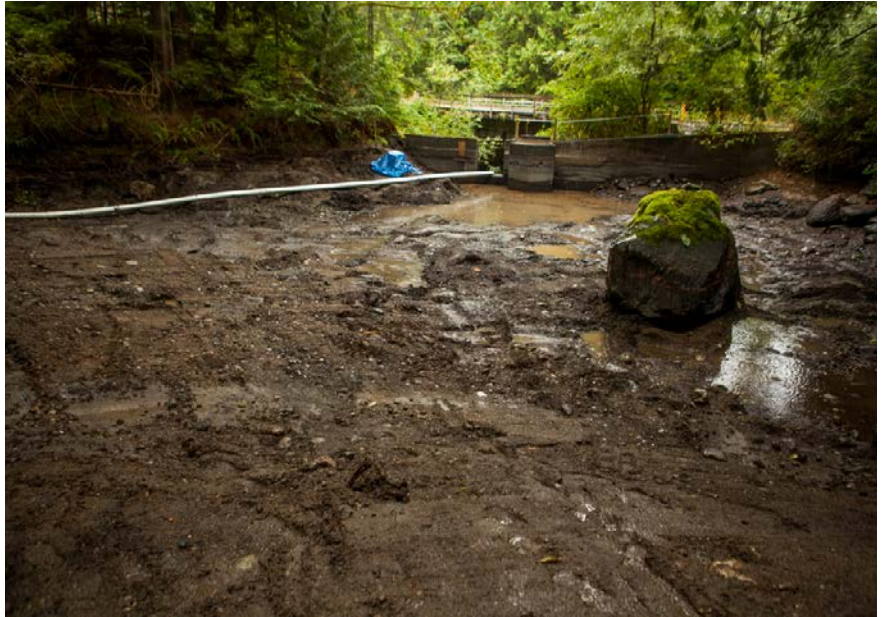
This view from the point where Terminal Creek enters Carter Pond, looking toward the dam, shows that the huge volume of sediment and trees have been removed.

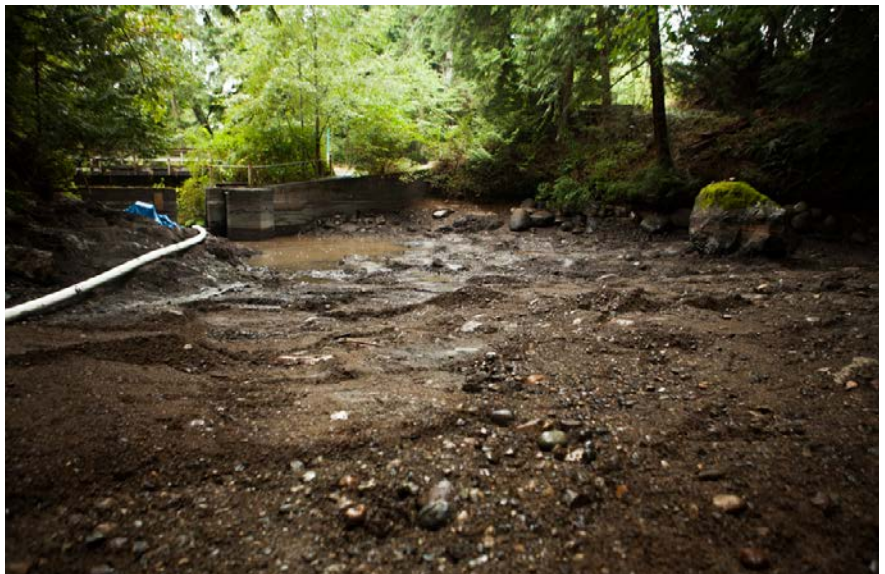
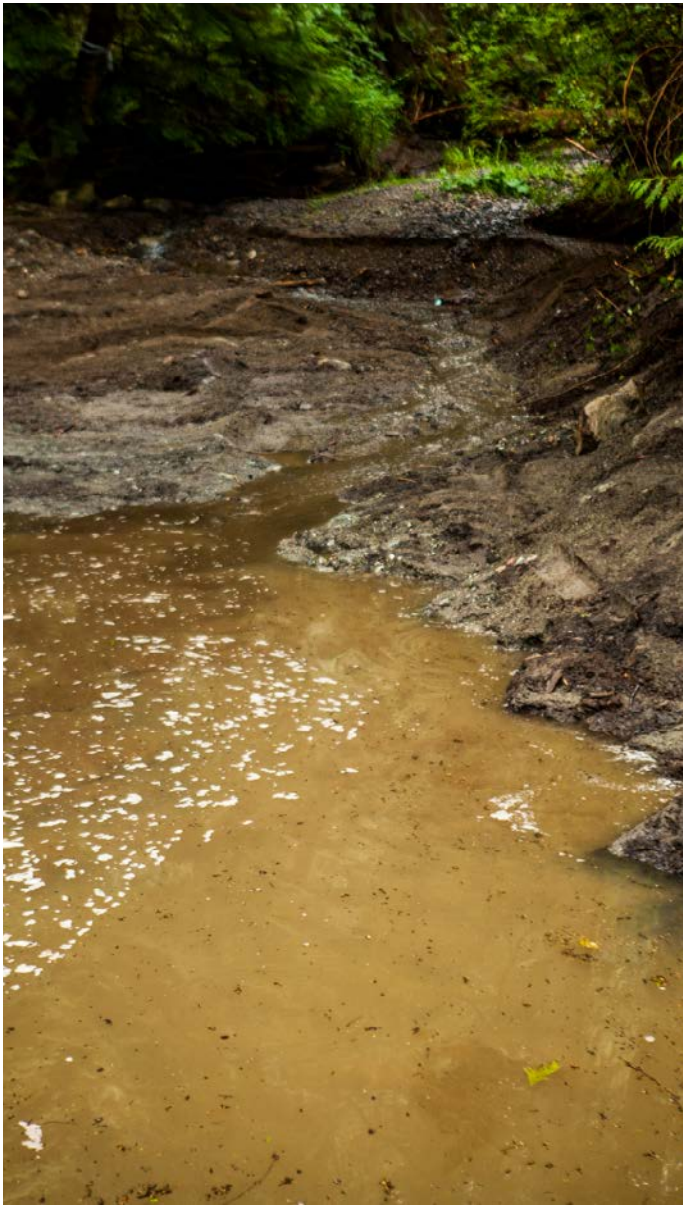
When all sediment has been removed, the pool at the entrance to Carter Pond is released and the PVC pipe removed. The pond refills and water soon flows over the dam.

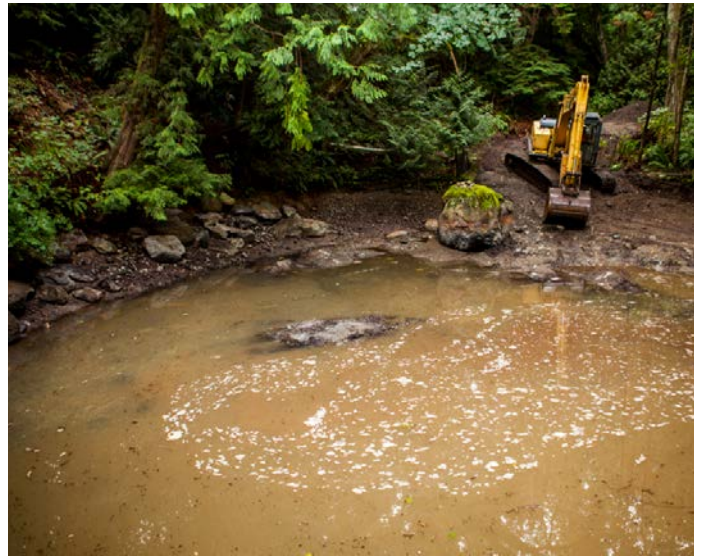
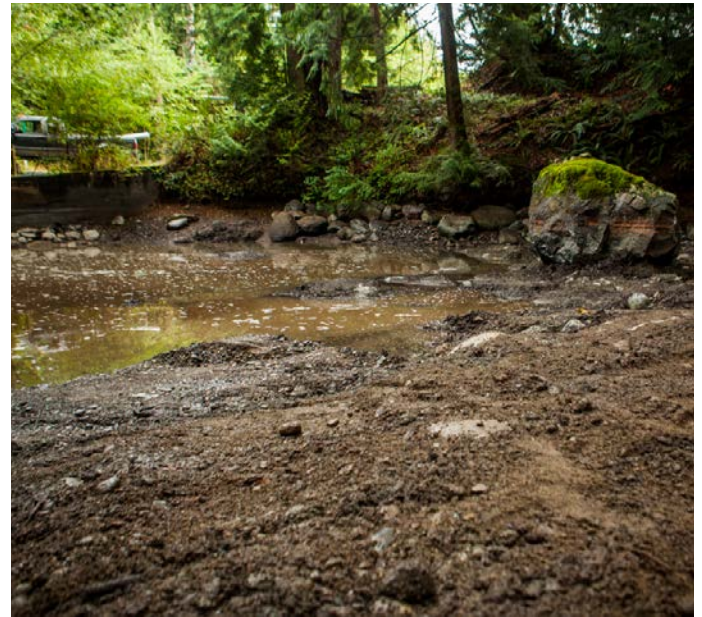
Dirt clouds the water at first but it soon clears. Within hours the water flow and turbidity in Terminal Creek downstream of Carter Dam is back to normal.

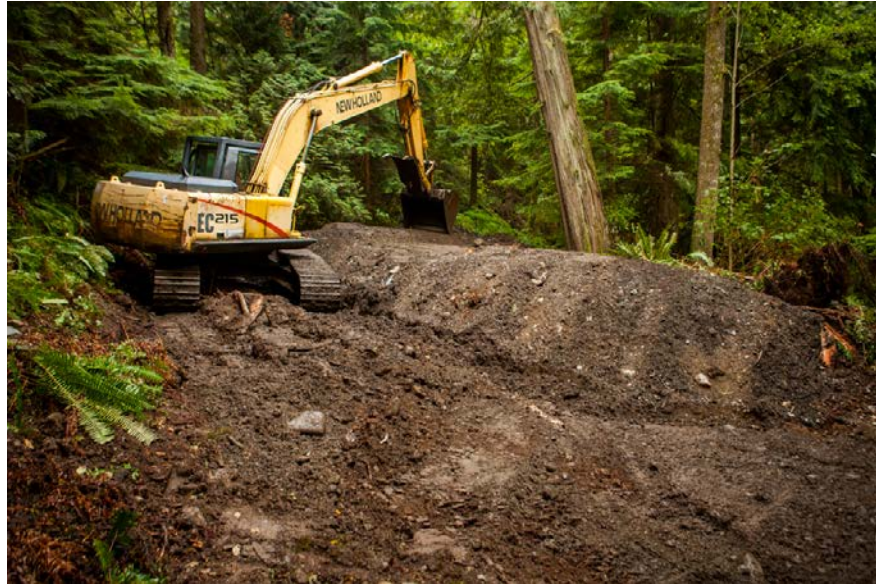
The relocated sediment, very organic material, is moved well back into the forest and leveled. Natural ferns and shrubs have been replanted and mitigation measures taken to assure sediment is not washed back into Carter Pond during heavy rainfall.

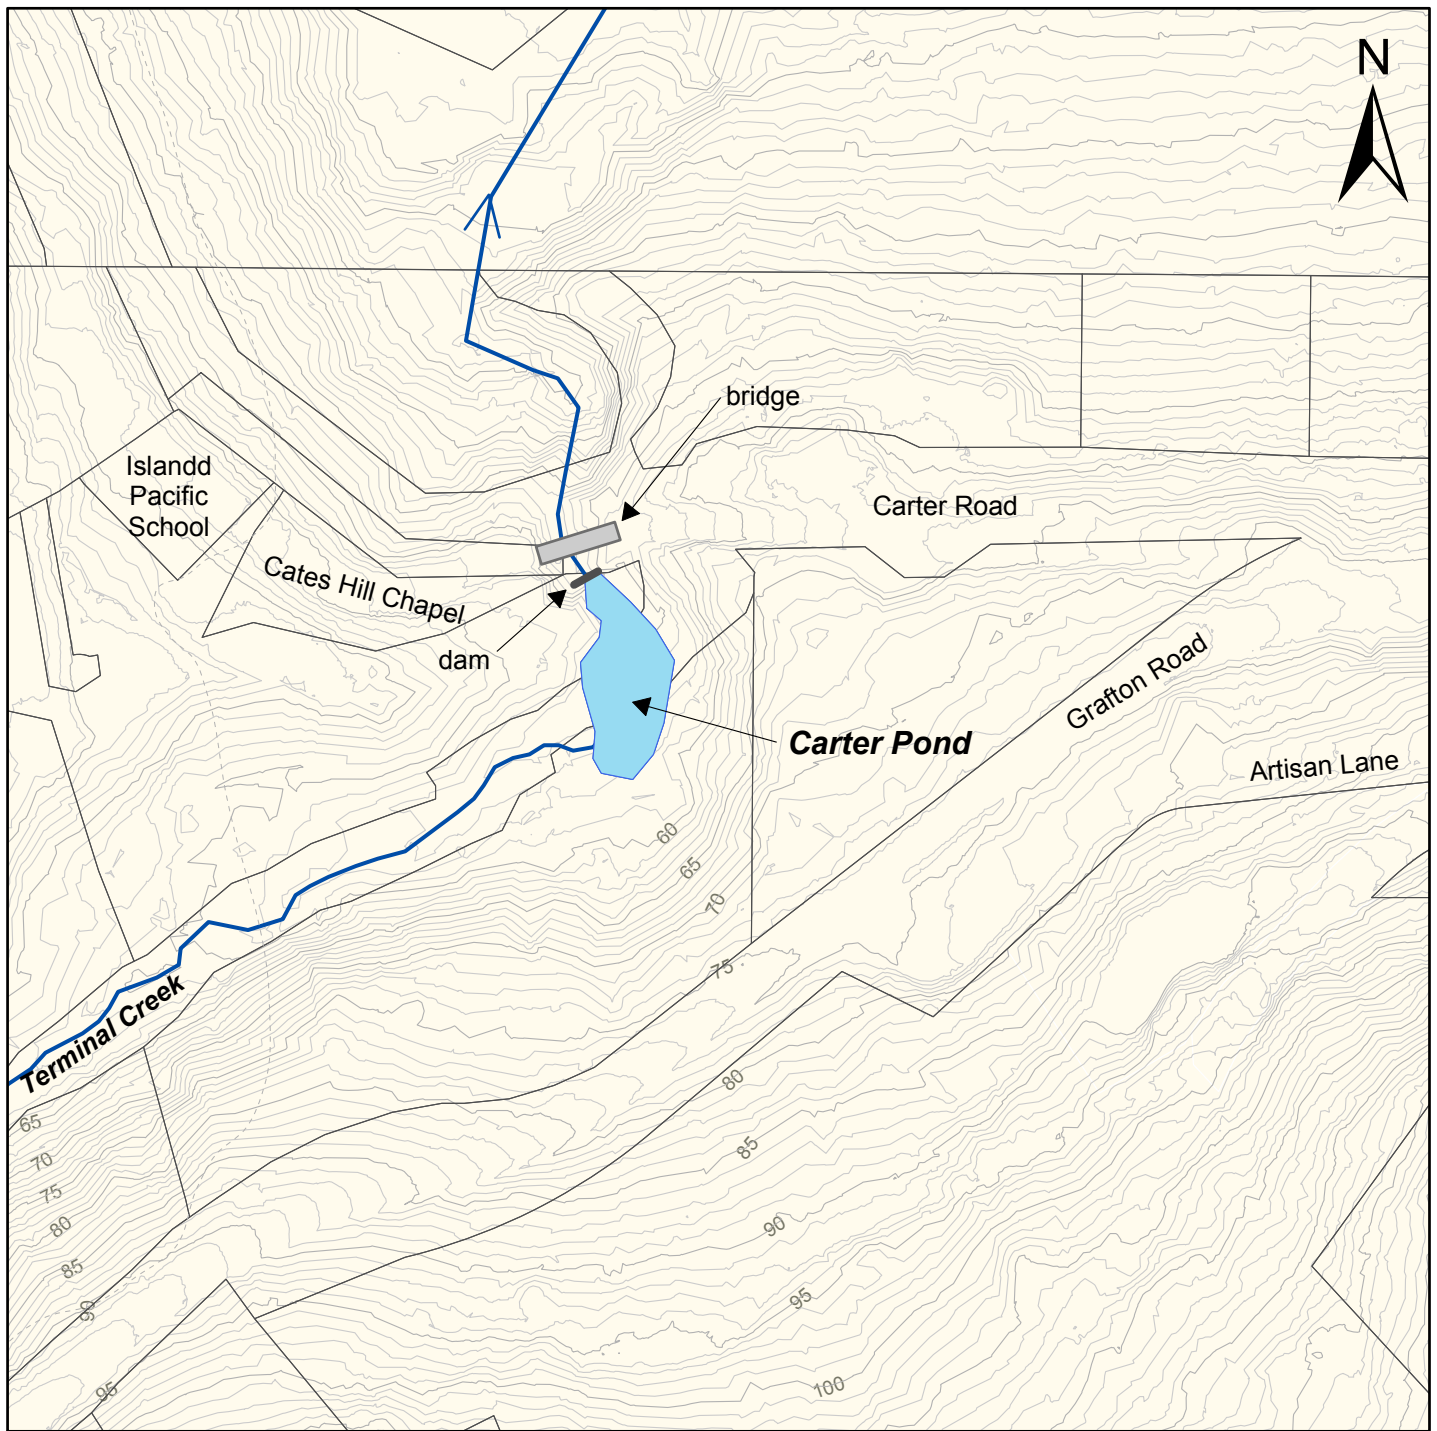
**Carter Pond Sediment Removal,
Bowen Island.**

Base map courtesy of the Bowen Island Municipality and Bowen Island Conservancy.
Topography based on LIDAR survey, 1 m intervals. All feature locations are approximate.
